# OPERATION OF INVERTER DC POWER SUPPLY FOR KLYSTRON

Y. Shoji, LASTI, Himeji Institute of Technology, NewSUBARU/SPRING-8, 678-1205 Japan

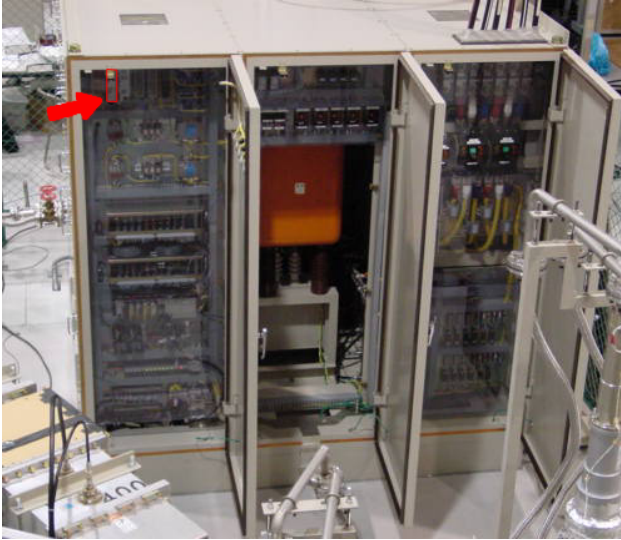
The small DC power supply ( $\pm 15V$ , 0.3A, Fig.2) was broken. It was used to control 15 DCCTs and switching relays. The trouble happened because it did not have enough power for them. The selection of small DC power supply unit was wrong.

The trouble happened at Friday night and we could start the beam commissioning at Tuesday noon. We spend our time to check all DCCTs and other elements. They were so tightly packed in a body in order to made it compact, that we had to remove many elements to reach to and check DCCTs. In this case maintainability was sacrificed for the compactness.

Figure 2: A small DC power supply (red rectangle) made the failure. The DCCTs are set at the bottom behind the foreseen plates for the circuits. The melted resistors are set at the top behind the foreseen plates.

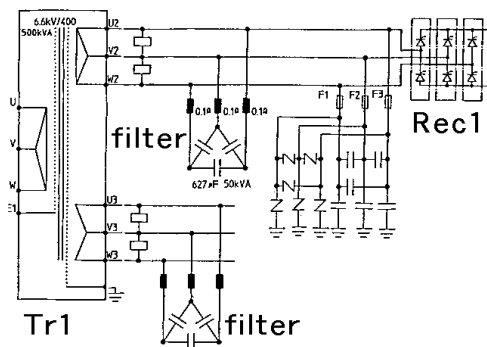
After the operation of 2 years it was found that resistors of a harmonic filter (Fig.3) for the primary 60Hz line melted (Fig.4). The ratings of the resistor and the conditions in the normal operation were listed in Table II. They were used in the condition closed to their ratings, above the recommended temperature for a long and continuous use. However there could be the other reason because their damage was terrible. One possibility was that they were resonant with 11th harmonic component of the primary line (660Hz), because the resonant frequency of the filter capacitance ( $627\mu\text{F}/\text{phase}$ ) combined with the transformer Tr1 ( $109\mu\text{H}/\text{phase}$ ) was 609Hz. However we could not reproduce that overheating condition. We are not sure about this point.

temperature	power
in operation (measured)	$>260\text{ }^{\circ}\text{C}$	1.1kW (primary 914W + commutation 180W)
rating	$350\text{ }^{\circ}\text{C}$	1.2kW
recommended	$250\text{ }^{\circ}\text{C}$	
oxidized	$>500\text{ }^{\circ}\text{C}$	
melt	$>1100\text{ }^{\circ}\text{C}$

Fig.3 Overheated filter. The black rectangles are the melted resistors.

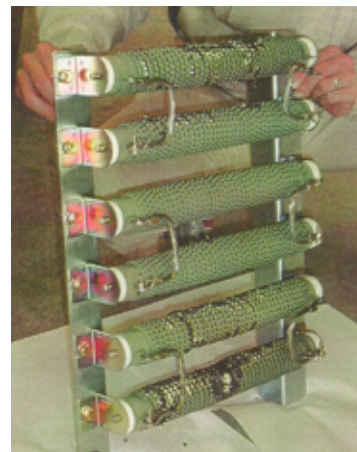
Fig.4: Damaged (melted) resistor array of the filter
