RF Fingers for the new ESRF-EBS storage ring

The ESRF-EBS storage ring features new vacuum chamber profiles with reduced aperture. RF fingers are a key component to ensure good vacuum conditions and therefore to reach the best performances. Our dedicated service has produced a more compact, robust and reliable design for the new machine.

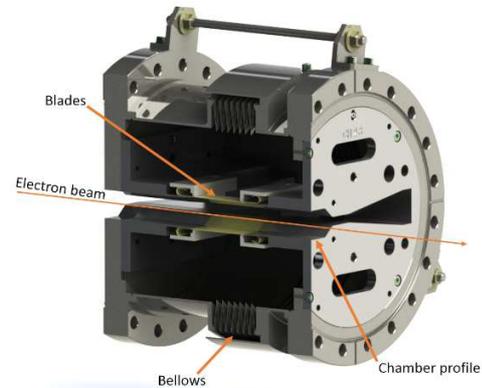
Figure 1 RF fingers placed in bellows

The new omega-shaped chamber profile is not compatible with the present RF finger design if geometrical continuity is to be enforced. A dedicated in-house design based on new concepts and principles was therefore devised for the ESRF-EBS ring. **Figure 1** shows the final design. It is the result of several iterations and optimizations of beam coupling impedance and mechanical properties.

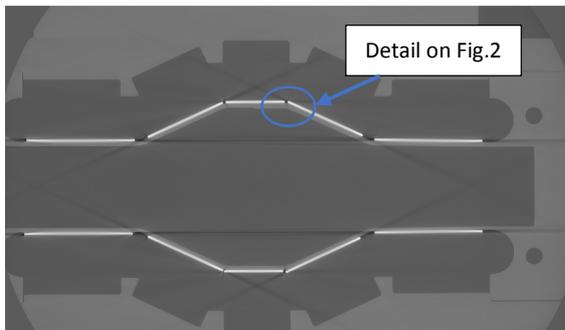
Figure 2: 10 blades contact view CT image

After reconstruction, it is possible to see the mechanical contact between blades and flanges at any position. The main point is the mechanical contact at the limit of the flange (Fig. 1 – Fig. 2).

The first step was to ensure that the cavity formed by the bellow was properly shielded from the beam. This was achieved by 10 blades (5 top and 5 bottom) as seen in **Fig. 2**. Once the bellow is invisible to the beam, the beam coupling impedance is strictly given by geometrical discontinuities of the inner volume: in this case the steps and tapers angle at the entrance and exit of the RF fingers can be seen in **Fig. 2**. The step height was fixed to 0.3mm for mechanical criteria and the only parameter left for optimization was the taper angle, a good compromise was found with a reduction of the taper angle from 5° to 2° leading to a reduction of the beam coupling impedance by a factor 4. This result was found satisfactory as the resulting full contribution of the RF fingers to the total impedance of the machine became significantly smaller than the contribution of beam pipes themselves.

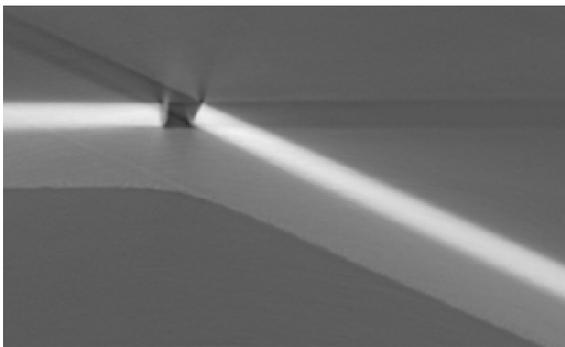
Figure 3: Detail view of blade contact on CT image

On images, at the $13.4\ \mu\text{m}$ pixel size resolution, the mechanical contact is perfect.

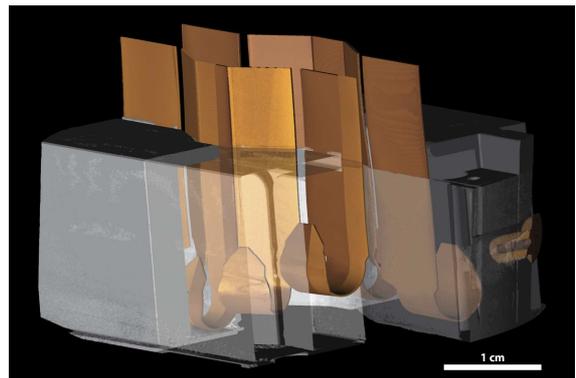
Figure 5: General view of 3D volume on CT images reconstructed

The electrical contact validation has been made using the computed tomography imaging technique at the ESRF BM5 beam line. Images were made with filtered white beam on a dedicated tomography setup to fix the RF-Finger and a PCO edge ccd camera mounted on an X-ray optic with $13.4\ \mu\text{m}$ of pixel size resolution for data acquisition.

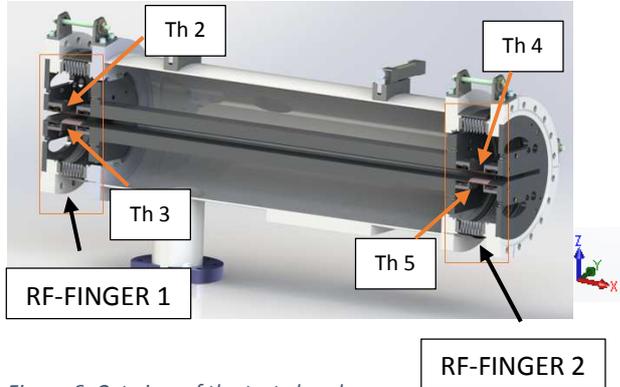
Figure 6: Cut view of the test chamber

The test bench used (Fig. 5) is made with a dedicated vacuum chamber equipped on both ends with an edge welded bellows and RF-Fingers in the bellows. Thermocouples were welded on the middle of the external part of the central blade, upper and lower, and connected to the data acquisition system. On the four thermocouples connected to the RF strips, only Th3 and Th5 were working during the test. The central part of the chamber is mounted on a double translation setup, one vertical (z) perpendicular to the beam and one horizontal (y) perpendicular to the beam. The x is the electron beam direction. Pressure gauges, penning type, were mounted on the upstream and downstream chambers.

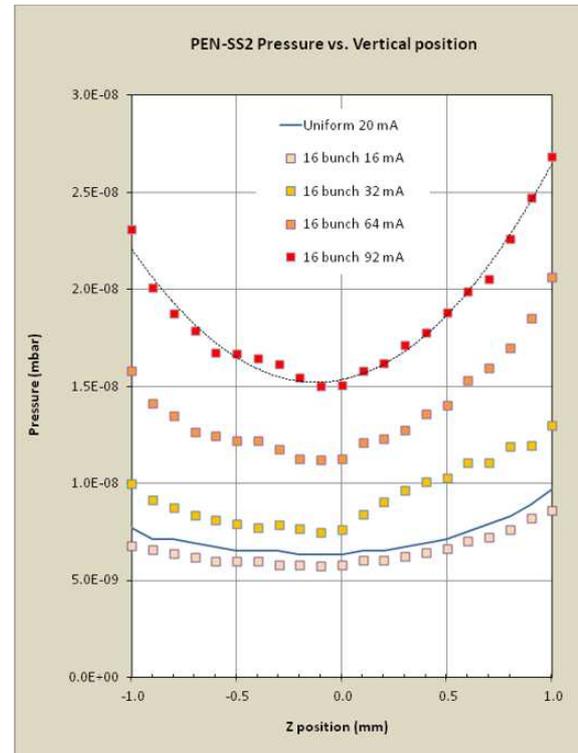
Figure 7: Pressure versus Z position

On the plot pressure versus Z position of the vacuum chamber (Fig. 6) it is easy to find the good vertical alignment. The pressure increase on miss alignment is linked to an increase of the temperature.

No vacuum problem signature seen.

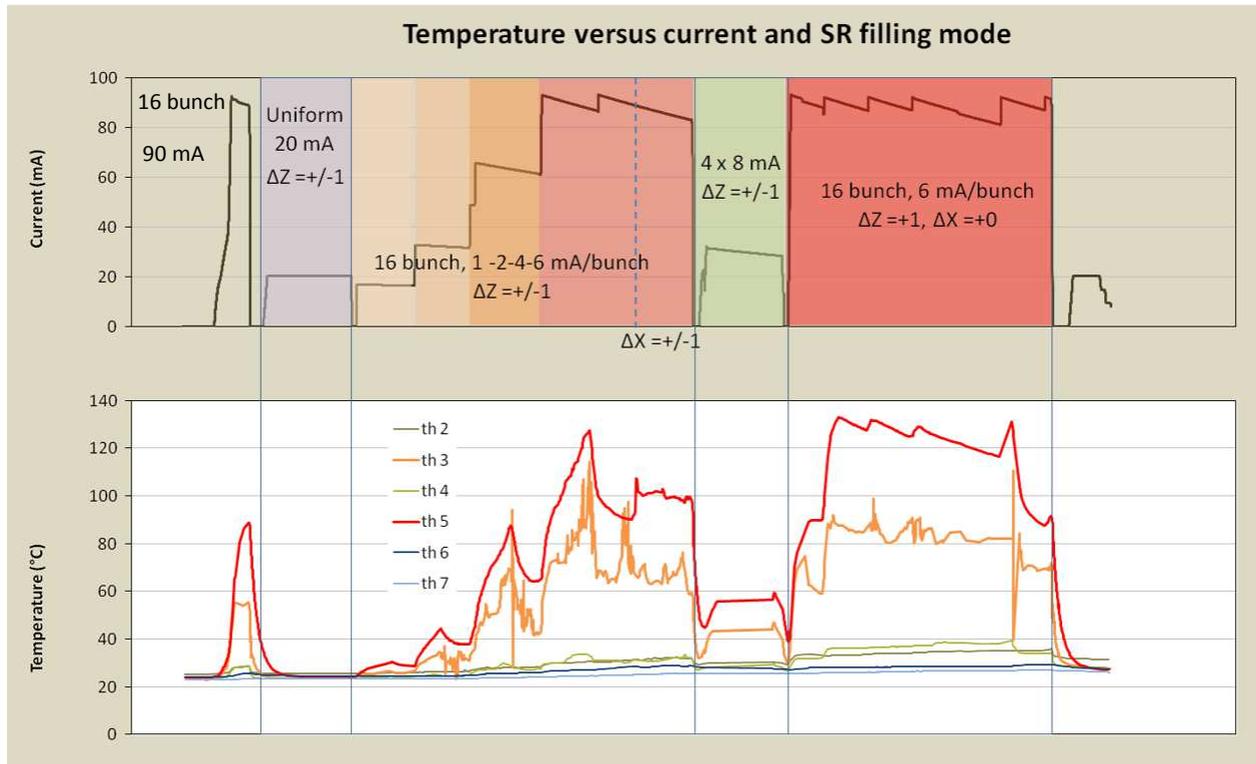
Figure 8: Temperature vs current and filling modes

The temperature increase with the current per bunch in normal conditions with a maximum temperature measured at 130 °C (Fig. 7).
